## Passenger Ferry Accidents in Bangladesh: Design and Socio-economic Aspects

Kho Shahriar Iqbal<sup>1)</sup>, Kazuhiko Hasegawa<sup>1)</sup>, Gabriele Bulian<sup>1,2)</sup>, Md. Mashud Karim<sup>3)</sup>,  
Zobair Ibn Awal<sup>4)</sup>

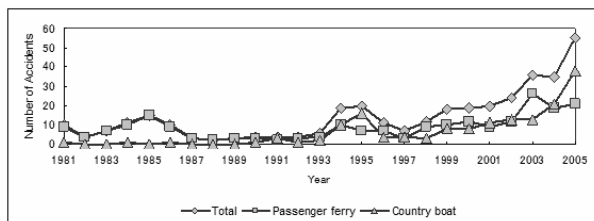
Figure 1: Number of accidents during 1981 to 2005.

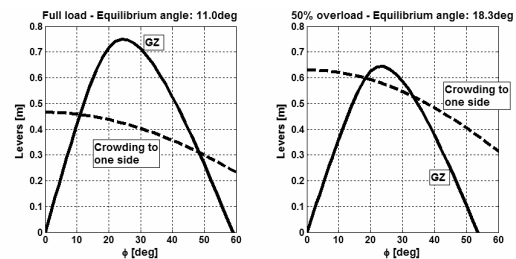
The calculated heeling moment due to passengers crowding to one side is significant (see Figure 2). In particular the situation is critical in the overloaded condition, where the increased weight of the passengers onboard leads to an equilibrium angle of more than 18 degrees, and, more important, to a residual range of stability that is very small, with an also very small maximum residual  $\overline{GZ}$ . In the overloaded condition, the ship can be in extreme danger during crowding of passengers to one side if some additional heeling cause, like the expected presence of wind, is introduced. It is important to note that, due to the very large B/T ratio of the ship under analysis, the  $\overline{GZ}$  curve shows, in both cases, a maximum at relatively small heeling angles despite the large metacentric height.

**Figure 2: Heeling moment due to passenger crowding.**

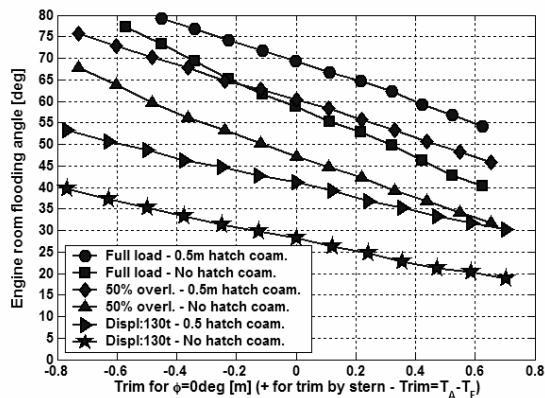
**Figure 4: Angle of submergence of the hatch leading to flooding of engine room in case of absence of hatch cover.**

Such hatch should be closed, however it has often found to be opened in operation, thus representing, in principle, a potential progressive flooding means. In some designs the hatch is provided with hatch coamings of having a significant height above the deck, whereas in other cases hatch coamings are, practically, not present. We have thus analyzed the angle at which the engine room starts flooding depending on whether a hatch cover is fitted or not. A representative height of 0.5m above the main deck has been considered for the hatch coaming and the effect of the initial trim has also been investigated. From the results shown in Figure 4 we can conclude that:

- Trim by stern should be carefully controlled;
- The fitting of sufficiently high hatch coamings as a significant positive effect;
- For the two basic loading conditions the downflooding angle is, in general, quite large. The same cannot be said for the ship sailing at the maximum draught.

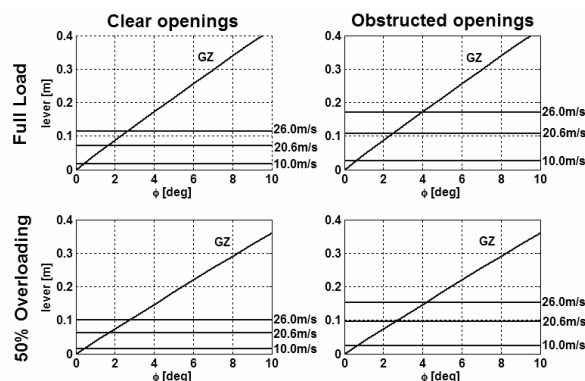
The results of the analysis are reported in Figure 5: the effect of the wind is, despite the quite large exposed area, not very significant and the equilibrium angle in the worst considered case slightly exceeds 4deg. This is due to the large metacentric height in the considered loading conditions. The wind itself, for not too extreme speeds, seems thus not to be a very dangerous hazard able to capsize the ship without the concurring effect of other heeling causes. Nevertheless, it is important to pay attention to the large variation of the heeling moment due to wind depending on the assumptions used. Globally when we consider the best and the worst case, we find a ratio of about 10.2 between the corresponding heeling levers, thus, the corresponding heeling angles. In view of the analysis of the wind carried out in this research, and considering the quite common bad habit of fixing the curtains at the side openings, it would seem more reasonable to consider, in the stability assessment framework, the openings as obstructed and a wind speed of 26m/s.

**Figure 5: Analysis of the effect of beam steady wind.**

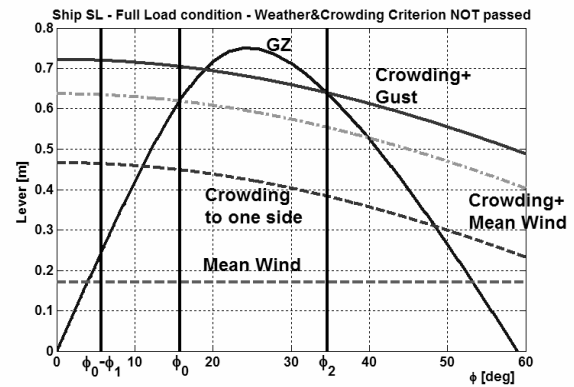
Figure 6: Application of Weather & Crowding Criterion in the full load condition.

For the crowding of passengers we have assumed, for this ship, a movement of 100% of the passengers onboard to a position equal to 70% of the half breadth of the ship. The application of the proposed criterion in the case of the "full load" condition is shown in Figure 6, with numerical data provided in Table 4: the ship

cannot pass the criterion. In addition, due to the small angle of deck submergence (slightly above 18deg), the requirement of a steady equilibrium angle below 80% of the deck submergence angle or 16deg, whichever the less, cannot be fulfilled. In the overloaded condition, the situation is even worse, because the ship cannot even statically sustain the combined effect of crowding to one side and mean wind (as it is clear from the results given in Figure 2 and Figure 5). It can thus be said that, from the application of the proposed criterion, the analyzed design should be considered as not satisfactory and potentially dangerous.

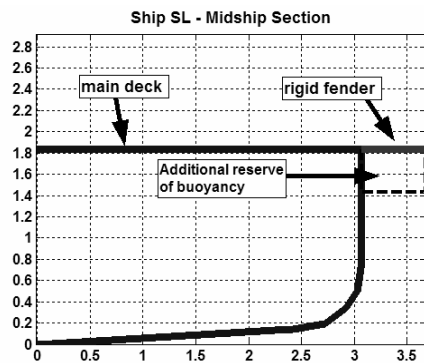
Figure 7: Rigid fender at the midship section.

We have thus considered the possibility of adding such buoyancy through totally enclosed inflatable lifting bags, to be fit in position under the rigid fender. Such buoyancy aids could be easily filled with air by means of an air pump connected to the main engine. In addition to providing additional buoyancy, they could be also considered effective as protections from collisions, thus increasing the inherent ship safety with respect to this latter hazard. Moreover, in case of breach of the hull, the presence of such bags, if not damaged, could provide a safe, though limited, additional reserve of buoyancy.

The selection of the dimensions of such buoyancy reserve is governed by the actual breadth of the fender and by the freeboard at the maximum allowed draught. The ship under analysis has a maximum allowed draught of 1.2m, with a depth of 1.83m. If we assume that 0.2m should be left clear between the waterplane and the bottom of the lifting bags, a maximum height of about 0.4m is obtained. It is to be said that such height could be increased by reducing the maximum allowed draught: the reduction in the maximum payload that the ship could carry would be compensated by the additional safety. The geometry and the position of the additional reserve of buoyancy are shown in Figure 7.

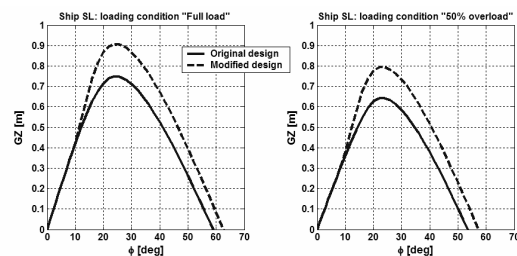
Figure 8 reports the comparison of the  $\overline{GZ}$  curves for the ship SL in the original and modified configuration, for the two tested loading conditions: the improvement in the  $\overline{GZ}$  curve for the two tested loading conditions is evident. The maximum still occurs at quite low heeling angles; however the value of the maximum has been increased, on average, by about 22%.

Figure 8:  $\overline{GZ}$  curves for the ship SL in the two tested loading conditions for the original and the modified design.

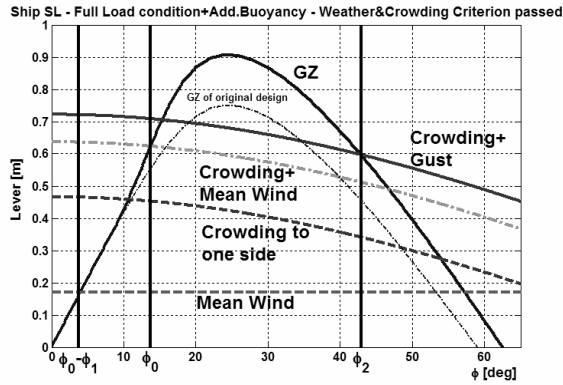
modified ship at the full load condition. The results of the application are shown in Figure 9 and Table 5, where it can be seen that the modified ship is able to fulfill the requirements thanks to the additional restoring. For sake of comparison, in Figure 9, the  $\overline{GZ}$  curve of the original design is also reported. Therefore, from the obtained result, it seems that the proposed modification is worthy attention, due to its potential of improving the safety of the considered ship with limited efforts.

Figure 9: Application of Weather & Crowding Criterion to the modified SL at full load condition.
